Rio Tinto

“Sir, we have 100 time-bombs in our new plant putting \$2b profit at risk...and we currently can't detect when they will go off”.

Dampier Port Upgrade Project

Pulley Failures at Parker Point

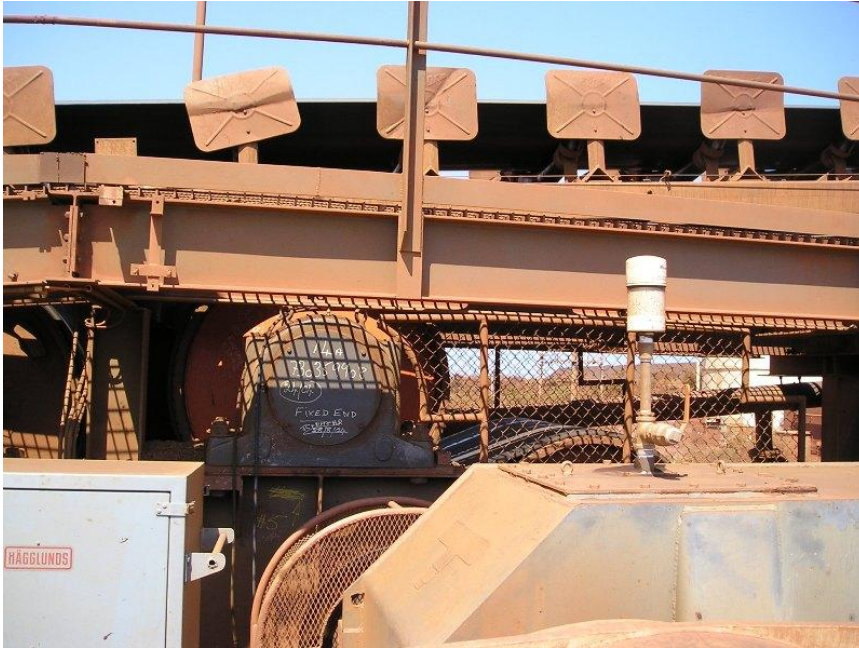
Pulley Assembly

Leave room to remove!

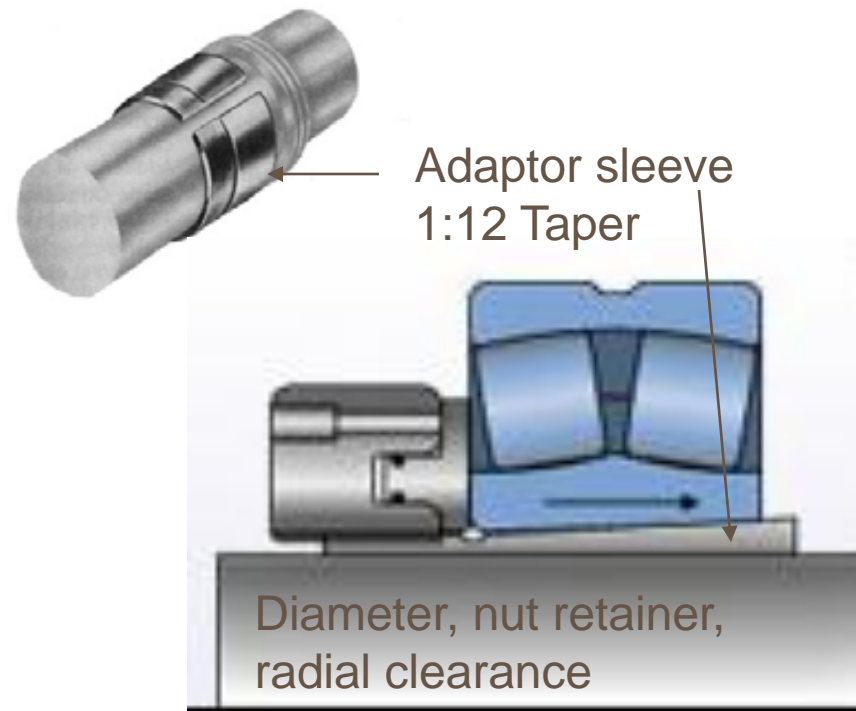
Pulley supplied by Sandvik, subcontracted bearings to NSK, subcontracted sleeves.

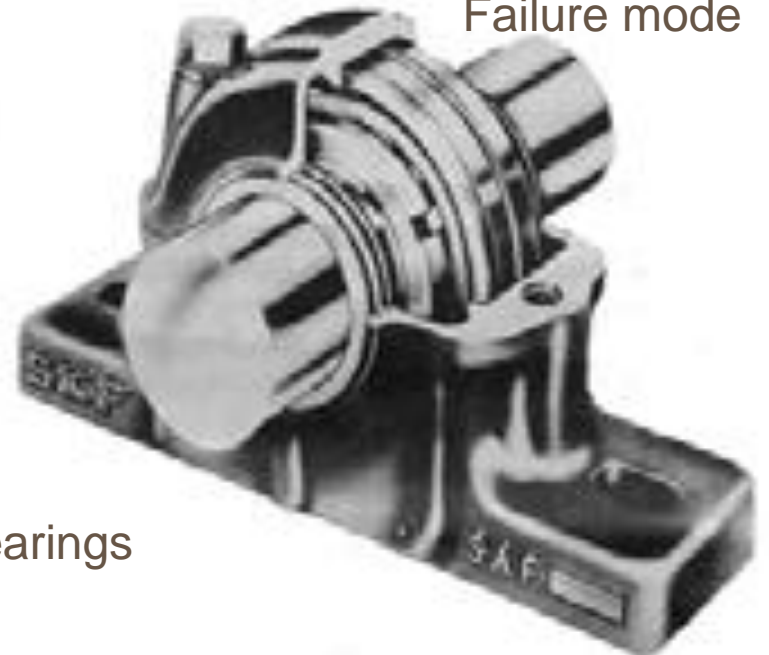
Failure mode

Location	Failure date	Equipment	Outcomes & Actions	Owner	Importance 1- High 3- Low	Due Date
Dampier	28/06/07	107P Pulley No1 bearing	The bearing inner ring had spun on the adaptor sleeves and the outer race contained spalling (rolling contact fatigue) that had initiated below the surface. Plan a detailed inspection program to ensure quality of DPU spare pulleys (housing centres, housing OD and ovality, bearing OD, shaft OD and ovality beneath the adaptor sleeve, bearing radial clearance, "ringfeder" bolt tension check, replace "SBE" ringfeder bolts). All spare pulleys to be inspected by 1/3/08. If significant non-conformance to standards are found then it will be necessary to plan changeouts of the most highly loaded pulleys from the field (get list from Sandvik).			Check spares
Dampier	28/06/07	107P Pulley No1 bearing	This pulley was not overhauled to our workshop standards. 109P location number 6 needs to be removed and correctly overhauled as soon as possible.			Replace Pulley- Stds

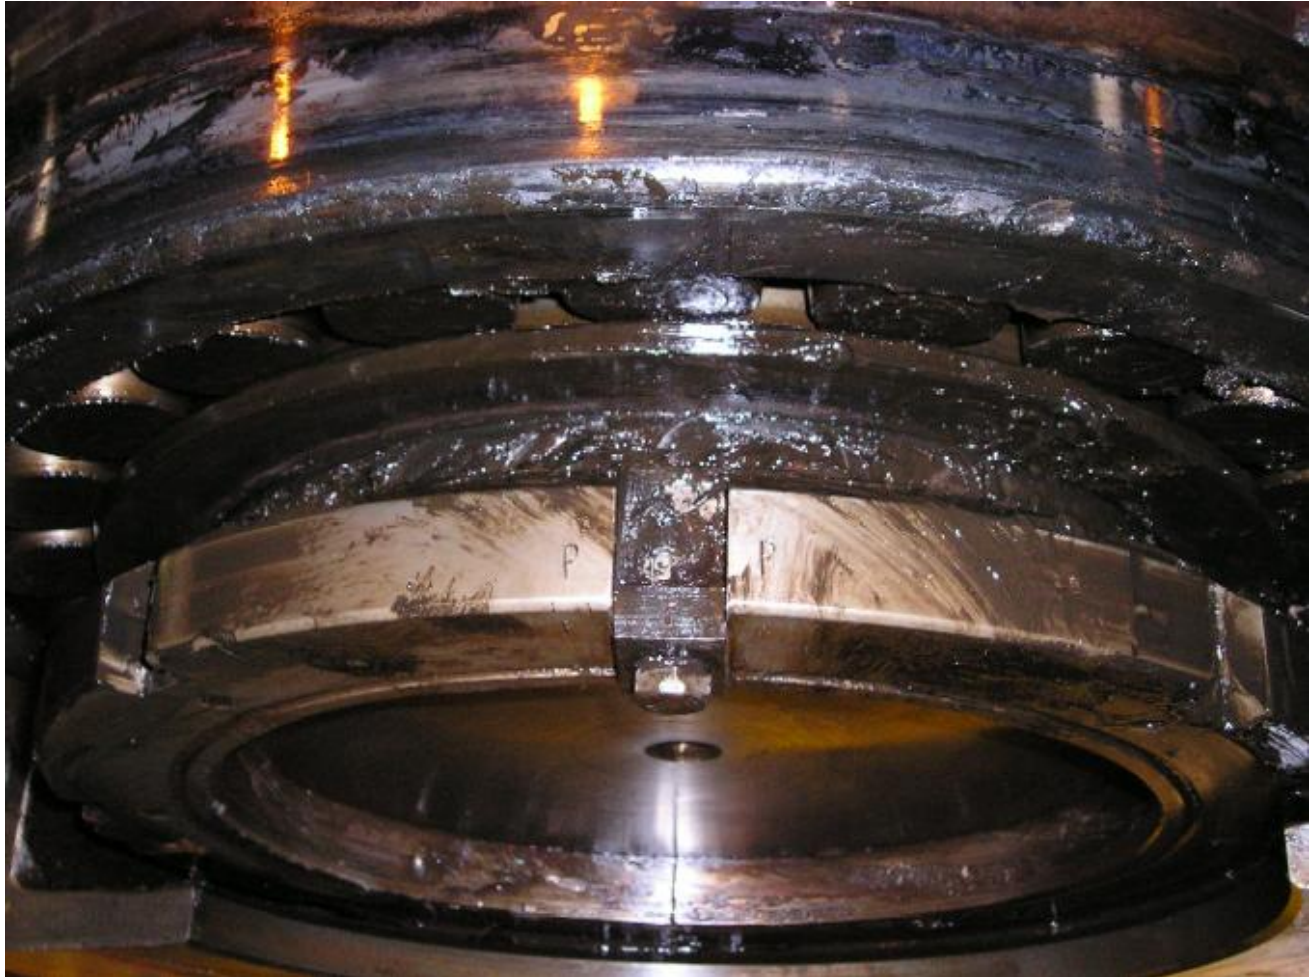
Sleeve moved on shaft

Dampier	18/09/2007	PPt DPU-A Pulley bearing failures (Tefco sleeve)	sleeves were manufactured to the wrong taper. Pursue warranty with the supplier of the pulley	Warranty		
Dampier	18/09/2007	PPt DPU-A Pulley bearing failures (Tefco sleeve)	sleeves were manufactured to the wrong taper. Ensure that sleeves are not used by Pilbara Iron.	Ban supplier and improve ITP
