Rio Tinto

“Sir, we have 100 time-bombs in our new plant putting \$2b profit at risk...and we currently can't detect when they will go off”.

Dampier Port Upgrade Project

Pulley Failures at Parker Point

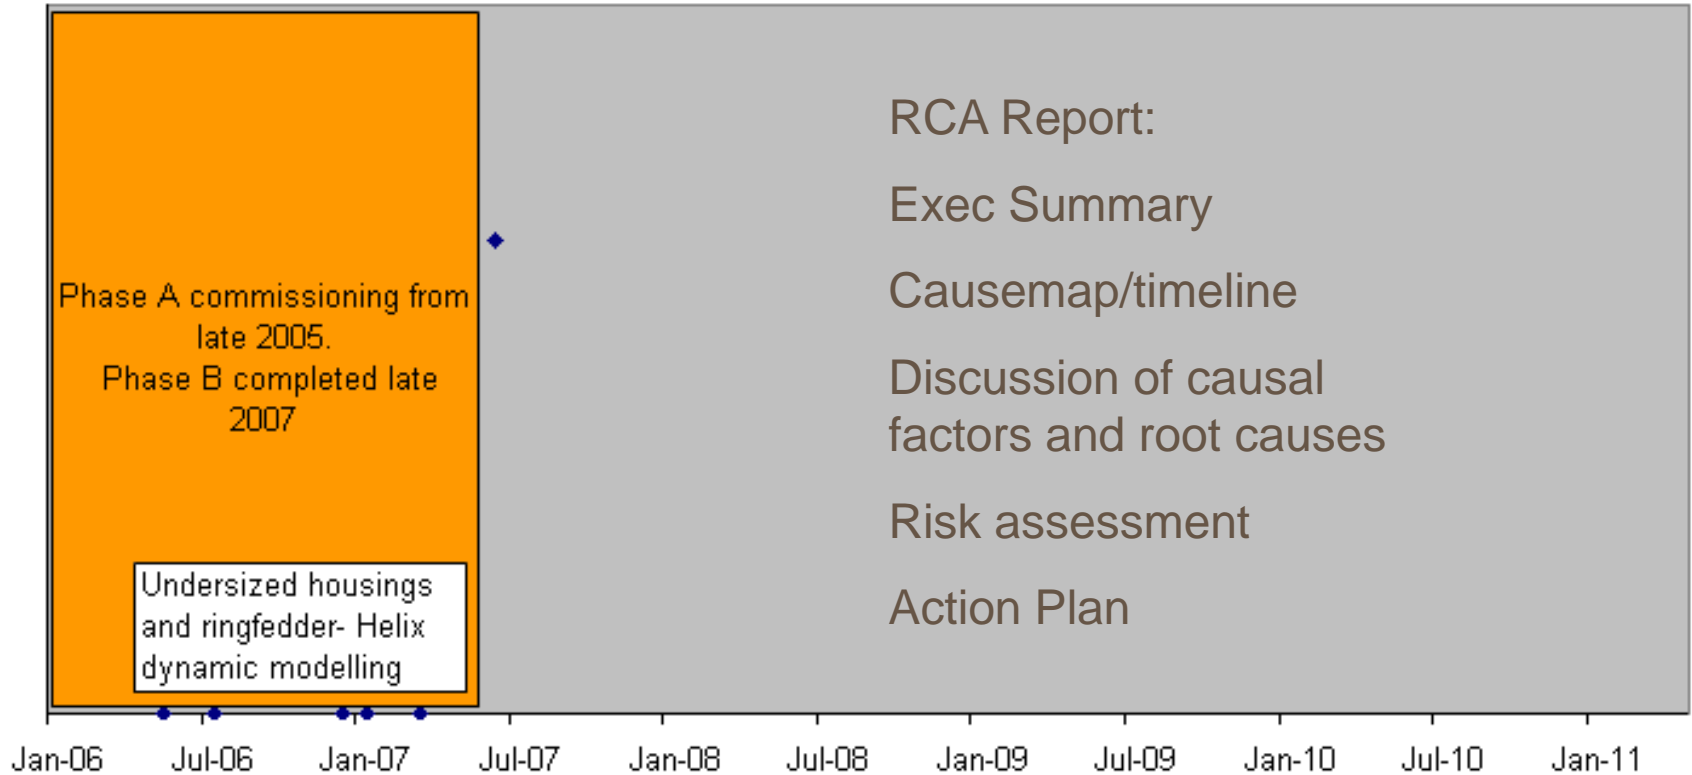
Timeline of pulley failures

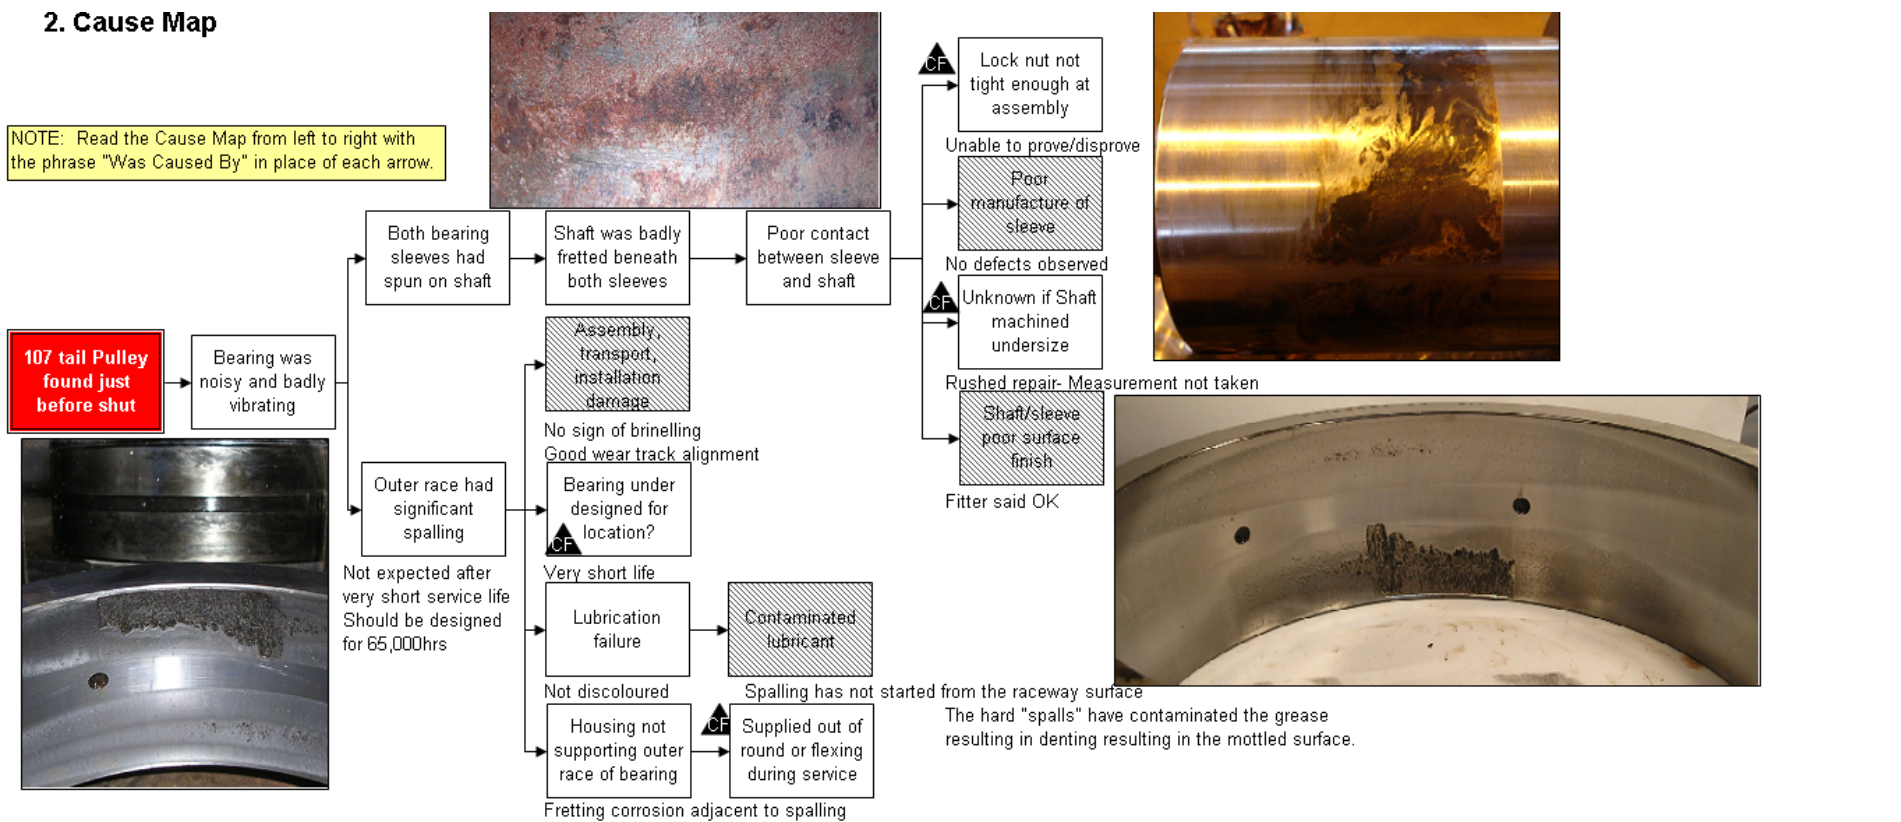
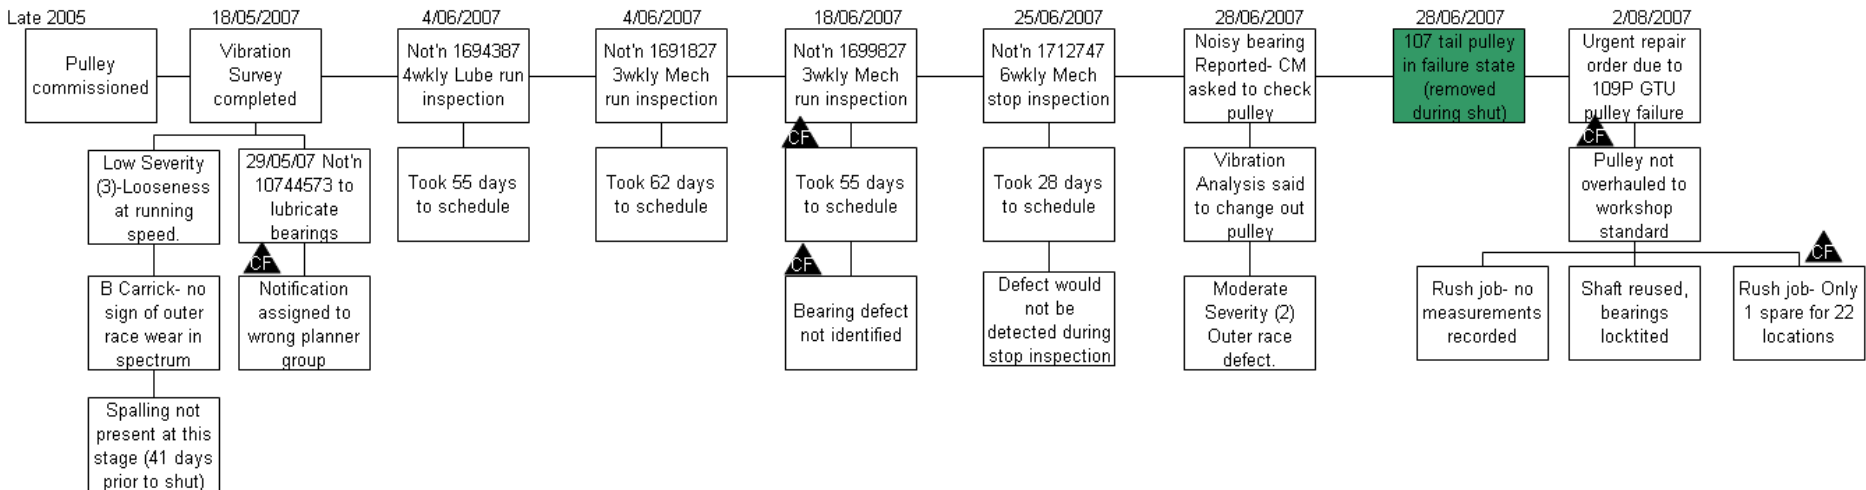
2. Cause Map

Location	Failure date	Equipment	Outcomes & Actions	Owner	Importance 1- High 3- Low	Due Date
Dampier	28/06/07	107P Pulley No1 bearing	The bearing inner ring had spun on the adaptor sleeves and the outer race contained spalling (rolling contact fatigue) that had initiated below the surface. Plan a detailed inspection program to ensure quality of DPU spare pulleys (housing centres, housing OD and ovality, bearing OD, shaft OD and ovality beneath the adaptor sleeve, bearing radial clearance, "ringfeder" bolt tension check, replace "SBE" ringfeder bolts). All spare pulleys to be inspected by 1/3/08. If significant non-conformance to standards are found then it will be necessary to plan changeouts of the most highly loaded pulleys from the field (get list from Sandvik).			Check spares
Dampier	28/06/07	107P Pulley No1 bearing	This pulley was not overhauled to our workshop standards. 109P location number 6 needs to be removed and correctly overhauled as soon as possible.			Replace Pulley- Stds

Dampier	28/06/07	107P Pulley No1 bearing	There was only one spare for 22 locations. Steve Warwick has created a spreadsheet to determine the pulley spares requirement for Parker Point (1 spare for 6 locations). Recommendations have been made to Angus Pidgeon to purchase the spare pulleys for Parker Point. Tom to monitor progress and ensure adequate spares are delivered.		1- High 01 05 2008	Purchase spares
Dampier	28/06/07	107P Pulley No1 bearing	PRM inspections and a mechanical running inspection 10 days prior to the shut did not detect the spalling on the outer race. Discuss this failure with inspectors and ensure they report noisy bearings via the notification system.			Improve inspections
Dampier	28/06/07	107P Pulley No1 bearing	PM01's are taking too long to schedule. A KPI needs to be created and tracked.			Improve Scheduling
Dampier	28/06/07	107P Pulley No1 bearing	The outer race contained spalling (rolling contact fatigue) that had initiated below the surface. Get Helix to check the design of this pulley for this location.			Check design- was under

Dampier	28/06/07	107P Pulley No1 bearing	Notification to lubricate the bearings was assigned to the wrong planner group. Technician now uses the correct planner group.

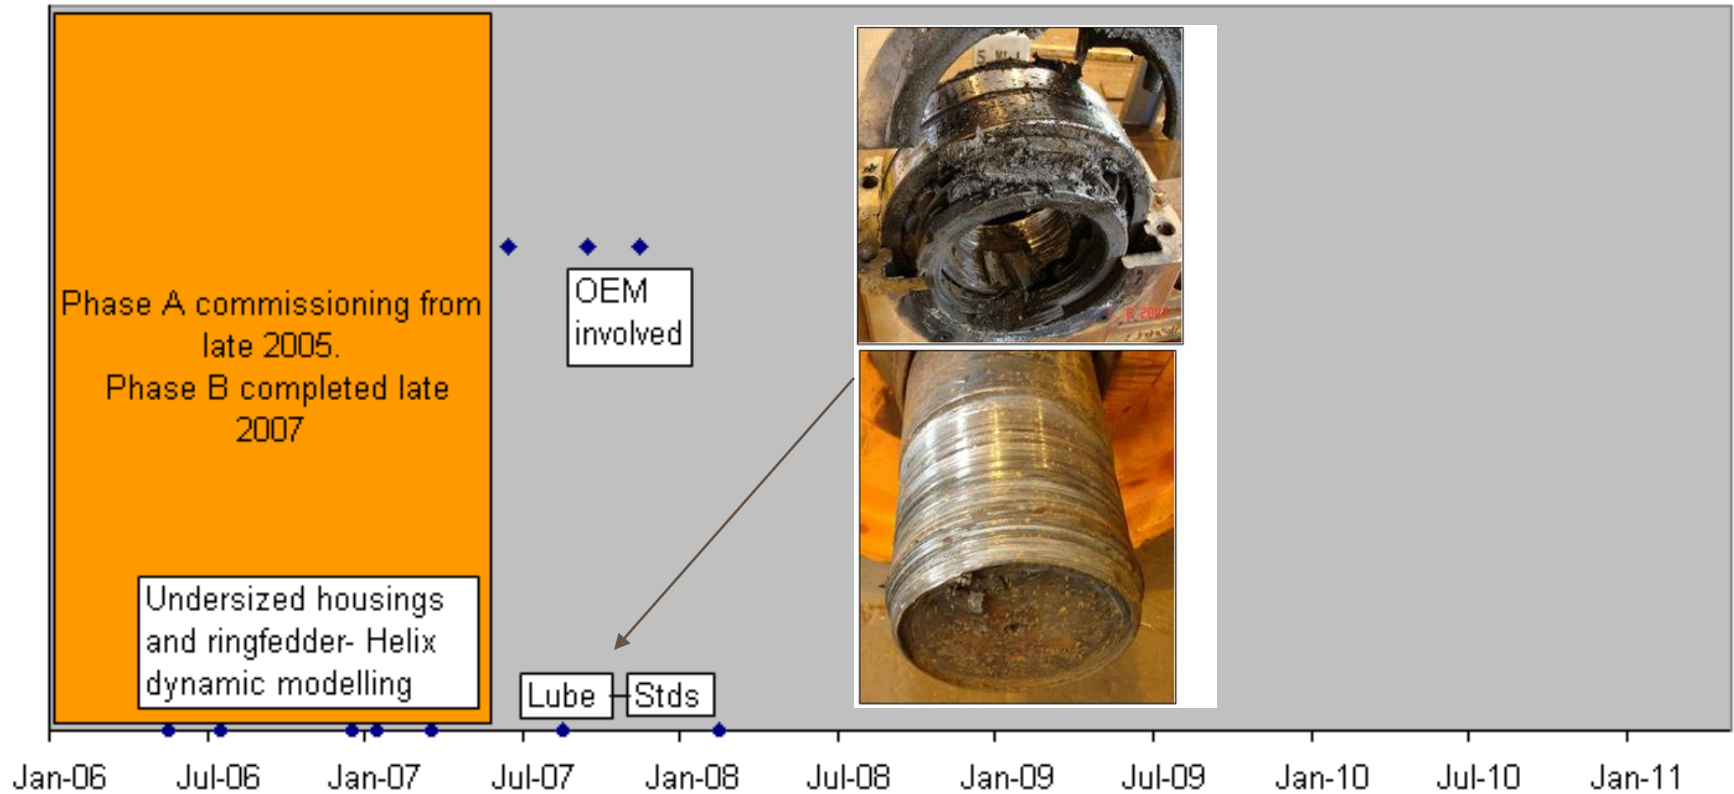
Pulley Failures at Parker Point

Sleeve moved on shaft

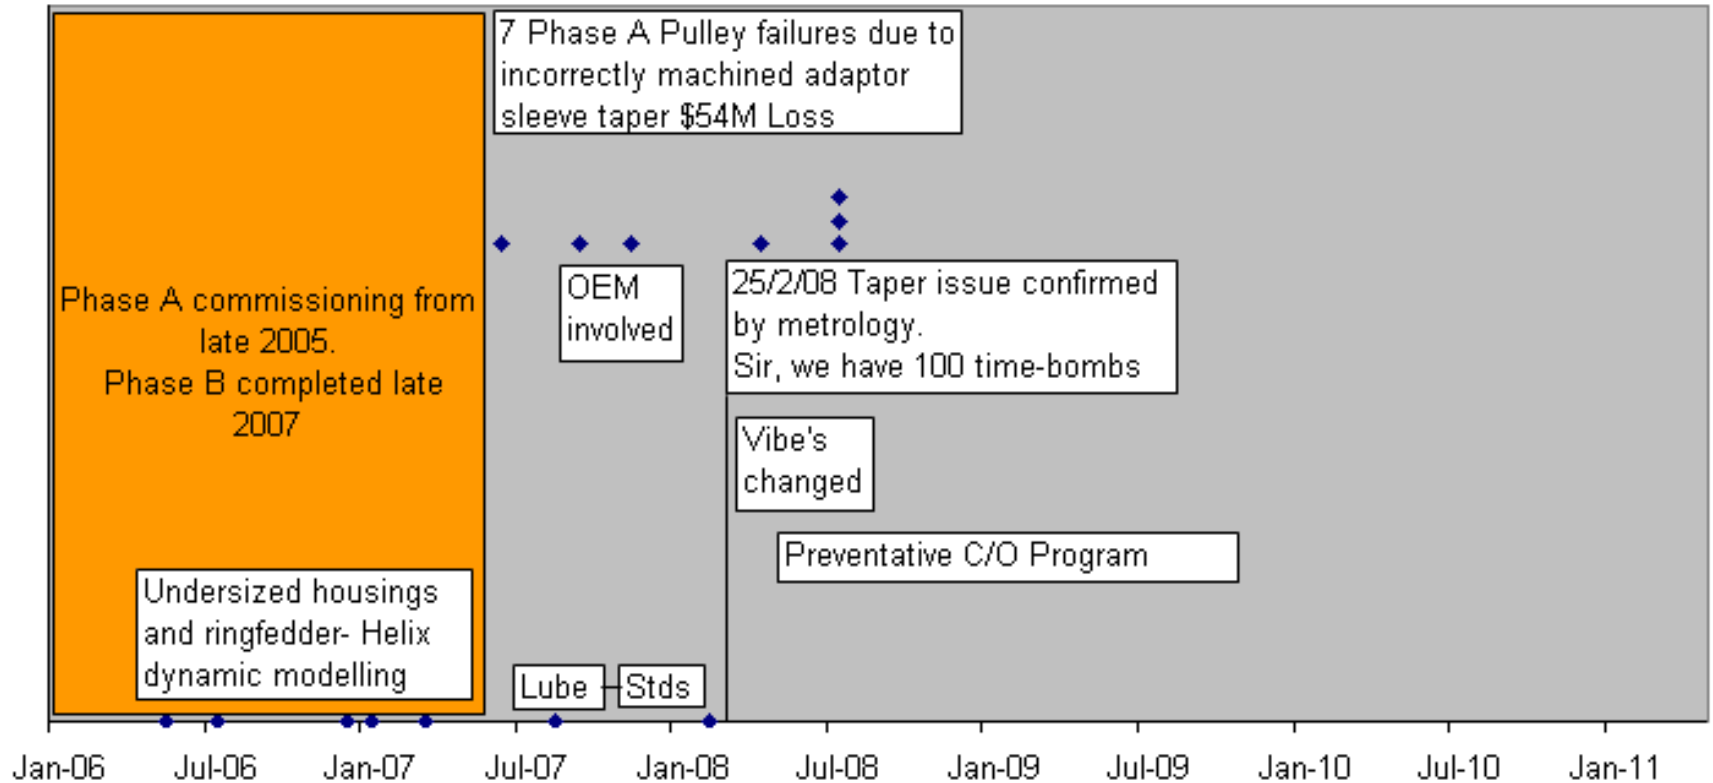
Pulley Failures at Parker Point

Location	Failure date	Equipment	Action Item	Owner	Importance	Due Date
Dampier	18/09/2007	PPt DPU-A Pulley bearing failures (Tefco sleeve)	Excessive time taken to changeout pulley (54hrs) because no procedure had been developed prior to the failure. A change out procedure should be developed for all PPt pulleys (new structures/beams may need to be installed into the plant).		Develop change out procedures.	
Dampier	18/09/2007	PPt DPU-A Pulley bearing failures (Tefco sleeve)	Excessive time taken to changeout pulley (54hrs) because beams to pull a pocket in the belt had not been included in the design of DPU. Update standards so that all future conveyor designs address access issues and include a procedure to change out pulleys (maximum of 12 hours).		Design in ability to do 12hr changes	
Dampier	18/09/2007	PPt DPU-A Pulley bearing failures (Tefco sleeve)	Bearings rapidly fail once they spin on the sleeve/shaft. Review other condition monitoring techniques that may give earlier warning of deterioration.		Improve CM to provide some warning.

Dampier	18/09/2007	PPt DPU-A Pulley bearing failures (Tefco sleeve)	Bearings rapidly fail once they spin on the sleeve/shaft. Increase the vibration survey interval to weekly for mainline and 3 weekly for non-mainline.		Increase survey frequency	
Dampier	18/09/2007	PPt DPU-A Pulley bearing failures (Tefco sleeve)	Bearings rapidly fail once they spin on the sleeve/shaft. Develop a change out plan for all mainline (then non-mainline) pulleys that have the same size adaptor sleeve that has caused this failure.		Implement preventative changeout plan

Dampier	18/09/2007	PPt DPU-A Pulley bearing failures (Tefco sleeve)	Bearings rapidly fail once they spin on the sleeve/shaft. Implement the change out plan for all mainline (then non-mainline) pulleys that have the same size adaptor sleeve that has caused this failure.	T Toledo	1- High	
Dampier	18/09/2007	PPt DPU-A Pulley bearing failures (Tefco sleeve)	Shift fitters are not experienced in pulley bearing change outs. Conduct training so that fitters can change bearings to an adequate standard.	Train shift fitters		
Dampier	18/09/2007	PPt DPU-A Pulley bearing failures (Tefco sleeve)	Pulley bearing failures can take significant time to recover from. A changeout kit to be developed to ensure parts and tools are available to quickly change a failed bearing (include belt clamps, cummalongs, bearings, hydraulic nuts etc).	Put kit together MTTR		
Dampier	18/09/2007	PPt DPU-A Pulley bearing failures (Tefco sleeve)	Spares may not be available to support the volume of breakdowns and changeouts. Determine and implement spares holdings and reorder points to ensure that we are not caught without a spare.	Review spares holdings

Dampier	18/09/2007	PPt DPU-A Pulley bearing failures (Tefco sleeve)	sleeves were manufactured to the wrong taper. Pursue warranty with the supplier of the pulley	Warranty		
Dampier	18/09/2007	PPt DPU-A Pulley bearing failures (Tefco sleeve)	sleeves were manufactured to the wrong taper. Ensure that sleeves are not used by Pilbara Iron.	Ban supplier and improve ITP

Develop and implement actions
